## CASE STUDY

## From Broken to Breathtaking

Eastpark 70 Building

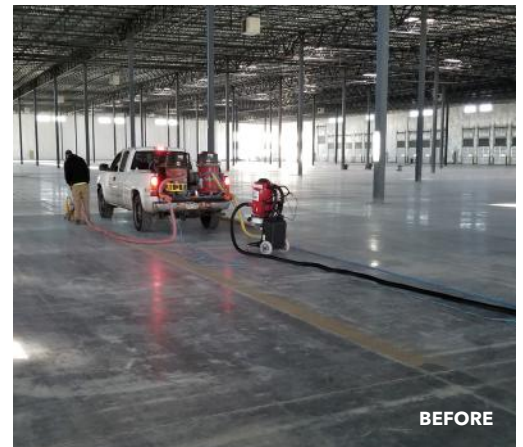
BEFORE

During the cleaning phase, these weak points gave way to reveal small, shallow, pockmark-like holes, ranging in size from 1/16 to 3/4 of an inch in width and between 1/32 and 1/8 inches in depth. These holes were present throughout the entire 250,000 square foot facility, along with saw scum lines, wind cracking and broadcast lines from wall forms being glued to the slab.

*The All West Surface Prep team cuts control joints into the facility's 250,000 ft<sup>2</sup> of concrete floors. This photo was taken prior to any grinding or densification work.*

1. Remove "pockmarks" via heavy grinding.
2. Dustproof the slab via chemical densification (Ashford Formula).
3. Re-establish the shine via burnishing.
